## MARYLAND HISTORICAL TRUST

#### R-ELIGIBILITY REVIEW FORM

BA 2693

#### Gwynnbrook Avenue Bridge

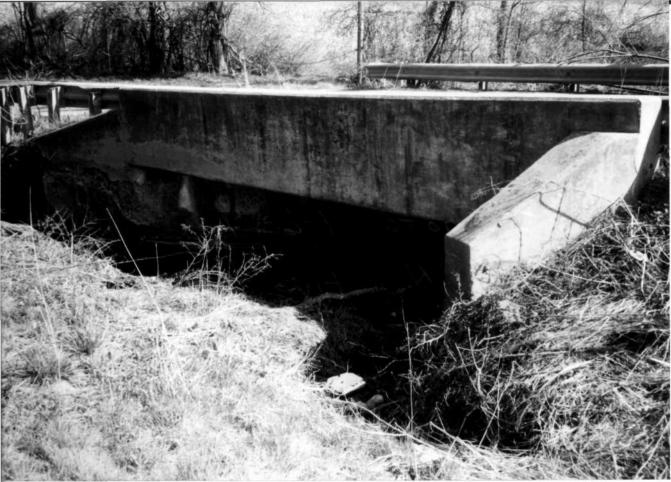
BA 2693 Gwynnbrook Avenive Bridge Saltimore County, MOST photography: Larry Murphy CUS ONE HOUR PHOTO: 4-6-04 Location of Negative MDSHPO North-Ederation of bridge photo 1 of 6

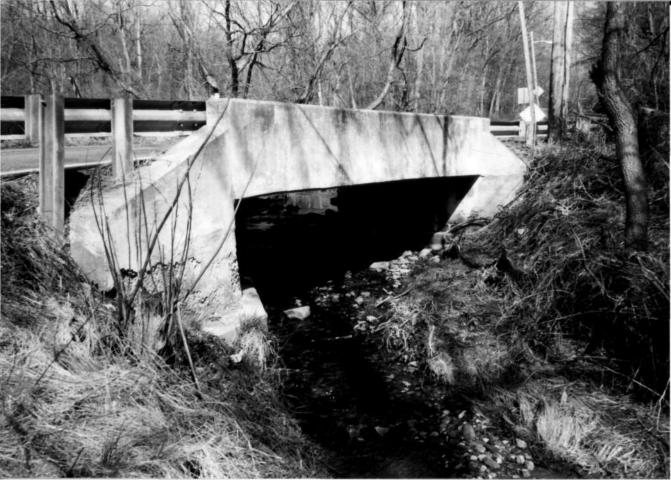
BA 2693 Gwynnbrook Avenue Bridge Baltimore County , mo photographer: Larry Murphy #--- 13UND4 CUS ONE HOUR PHOTO Location of Regutive: MDSHPO South elevation of bridges looking - portheast photo 20 f 6.0

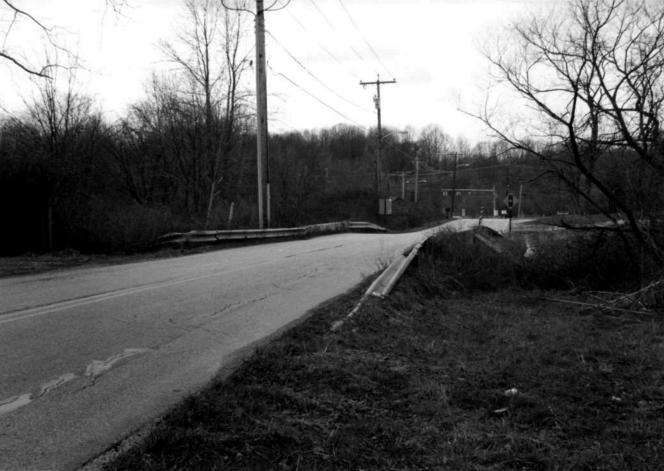
Inventory # BA 2693 BOTOZ- GWYNN BROOK AVEOVER ATRIBUTAR Name DF GWYNNS FALLS
Name OF GWYNNS FALLS
County/State BALTIMURE COUNTY/MD
Name of Photographer DAVE DIEHL
Date1 95
Location of Negative SHA
Description EAST APPROACH LOOKING WEST
Number 2 tof 3 + 4
